THE NYMBOIDA POWER(LESS) STATION

Is it economically viable, or an ecologically sustainable proposition?

July 2007

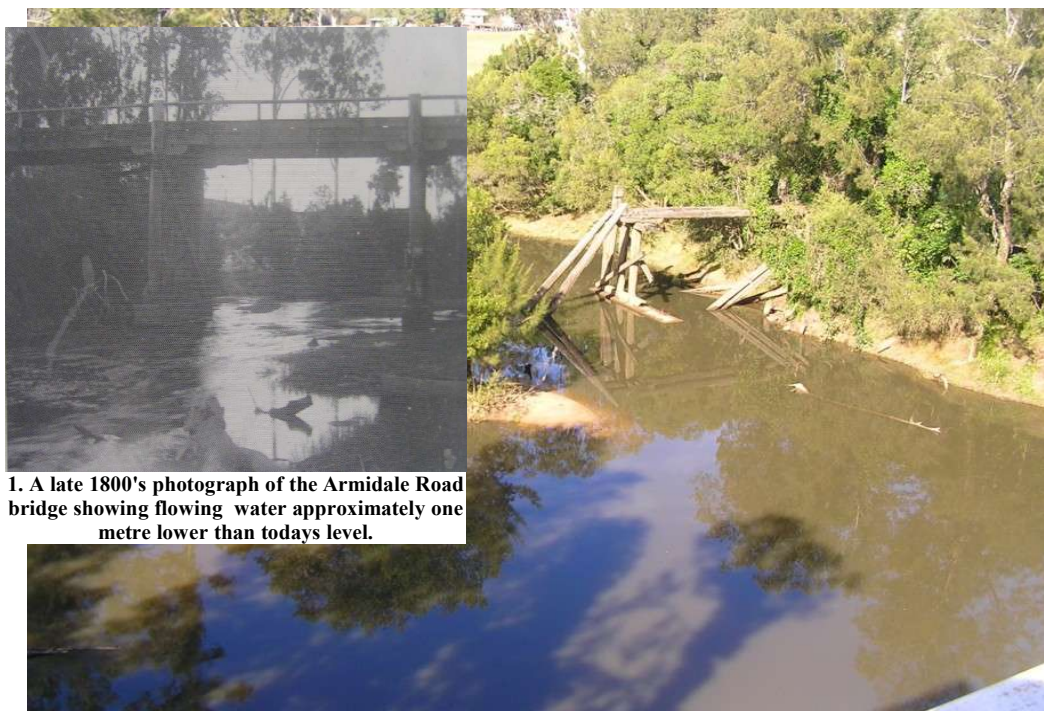
1. A late 1800's photograph of the Armidale Road bridge showing flowing water approximately one metre lower than today's level.

2. The ruins of the old Armidale Road Bridge across the Orara River at Coutts Crossing. Today's ponding water differs from the free flowing water in the late 1800s (see inset). This is the direct result of siltation from Blaxlands Creek, a kilometre downstream.

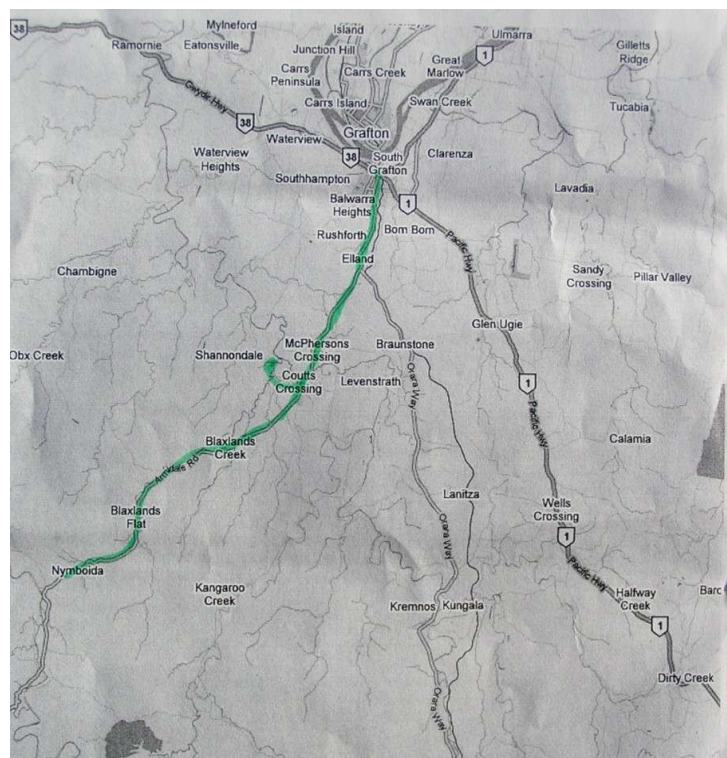
3. Blaxlands Creek (marked in green) where the CMA is active.

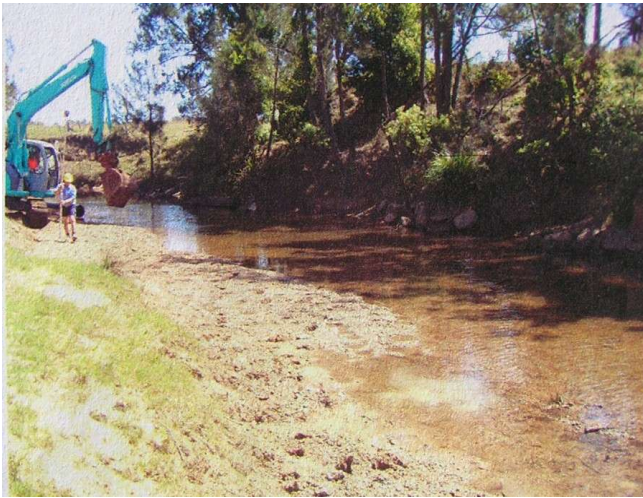
4. CMA photograph, Blaxlands Creek before rehabilitation

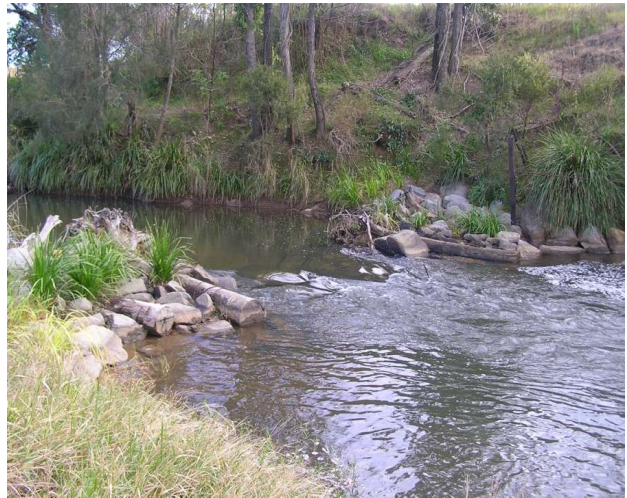
5. 18 months later, with structures in place

In-stream works include artificial rock and log structures put in place to interrupt flows, to produce riffles and form islands, with the aim of slowing erosion of the creek bed.

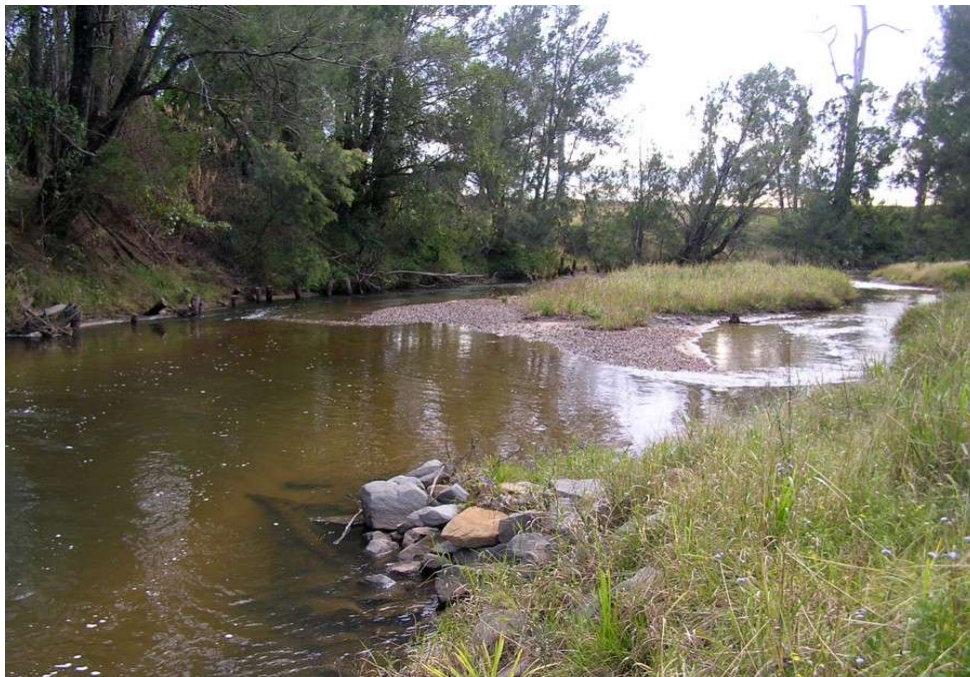
6. A 'manufactured' island, allowed to form naturally after placing posts in the river.

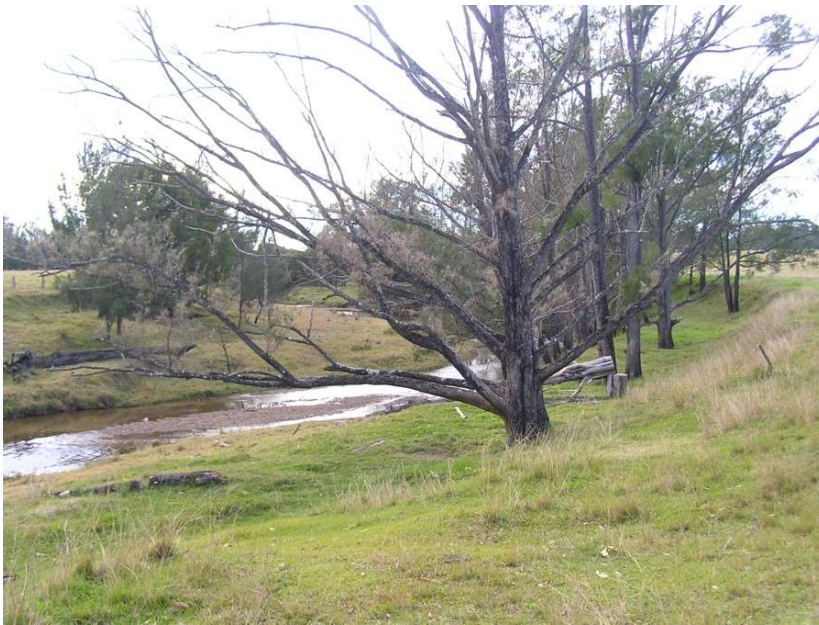
Unfortunately evidence of past erosion is clear all around. Anecdotal evidence provided by landowner Mr Ossie Ellis, is that when the power station was built, when he was a child of 13, the Blaxlands Creek bank-tops were less than 10 metres apart. Today the width between the banks is in the vicinity of 40 to 50 metres (see below). However, it is not just the banks that have been scoured. The creek-bed where the stream crosses the Orara flood plain has also been seriously eroded, and is now estimated to be at least three metres lower than it was 100 years ago.

7. The obvious degradation of Blaxlands Creek where the distance between bank-tops is now close to 50 metres. Anecdotal evidence suggests that distance was only 10 metres when the power station was built in 1924.

- ▶ Cattle may not be totally excluded. Fence-lines on either bank-top being as far as 60 metres apart means a considerable area of what graziers may see as 'wasted' land (see picture 7 above). Short periods of grazing will be seen as acceptable, or even beneficial. The concern we have is, will it be possible to prevent landowners from utilising that feed source, particularly in the event of a serious drought?

- ▶ There is a worrying level of River Oak deaths (*Casuarina cunninghamii* along the creek (picture 7 above). No investigation into the deaths has been undertaken. With no evidence of regeneration, and a water supply still present, suggestions that this is the result of either old-age or drought cannot be supported. It should be noted that the site of the regional water supply's dam at Shannon Creek has been contaminated with the die-back pathogen, *Phytophthora cinnamomi*. Heavy machinery is a major cause of the spread of this disease, and machinery that was used extensively at the contaminated site was also used to excavate a trench across Blaxlands Creek in 2002 for the Grafton to Coffs Harbour pipeline. As the proponent made no attempt to implement the recommendations of a *P. cinnamomi* Plan of Management to prevent spread of the disease, there is a possibility that the disease could have been transferred to Blaxlands Creek. This possibility should be investigated as a priority.

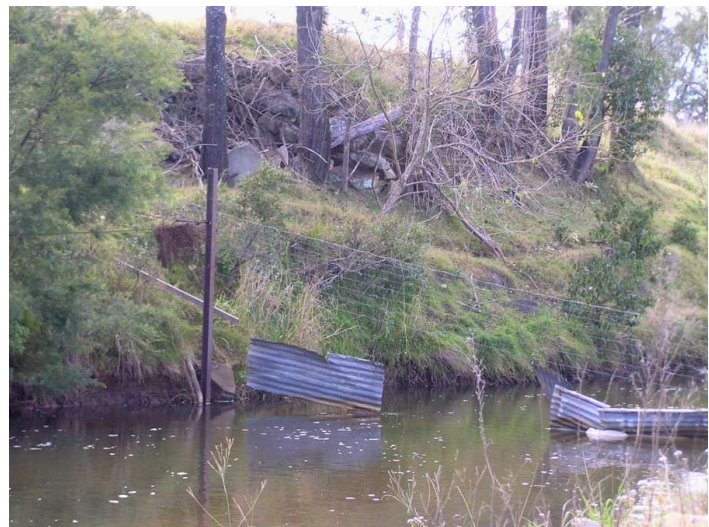
These earlier rehabilitation attempts involved railway line posts and steel cables, which are still in place. The photograph (right) shows one upright post to the left of the sheet of corrugated iron, now forming part of a fence across the creek. It was explained that the point where the wooden brace is attached to the steel post was the approximate level of the creek-bed when the works were undertaken.

8. Evidence of past erosion

This means the bed has eroded by at least 2 metres in the past three decades. It is hoped that the new works currently being undertaken will halt this trend by interrupting the sedimentary flows.
